SUCCESSFUL CASE STUDY

COATING STREAK & SCRATCH DEFECTS ARE NO LONGER UNATTAINABLE!!!!

HIGHLY ADVANCED STREAK ENHANCEMENT TECHNOLOGY

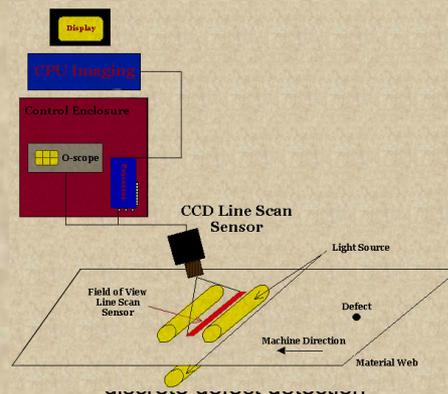
Figure 1 – Diagram of RKB system for hole/spot defect detection

The RKB system for discrete defect detection can work both with reflective and transmissive light for defect detection, classification and mapping. The principle of this part of the system is as follows: a lens is imaging periodically a line across the web surface into a linear array of CCD (Charged Coupled Device) pixels (photosites, photodiodes). The quantity of light collected by each pixel is independent from the other. An increase or a decrease of the energy collected by a pixel above or below a fixed threshold indicates that a hole (light or bright spot) or a dark spot is present on the web surface. If more than one-pixel experiences an increase or decrease of energy at the same time, then the defect can be, and is, classified into three main categories (small, medium or large), depending on the number of pixels affected.

Since all inspection solutions require a transmission of luminance and a collector of that luminance (i.e., light to camera) of some form to operate, these lighting and sensor techniques and types are very critical to a successful detection system. The system RKB provided Reno consists of two configurations, one for discrete defects such as small dirt and one for subtle continuous defects such as coating streaks. A schematic of the system used for discrete defect detection is described in *Figure 1*.

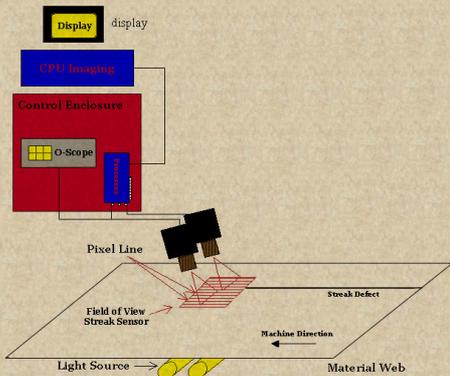
Figure 2 – Diagram of RKB system for subtle continuous defect detection

As shown in *Figure 2*, transmissive light can be used for the detection of subtle continuous line defects using RKBs OPTO-TEK II® Streak Cameras developed and patented by RKB. This detection technique, as with the technique used for discrete defects, can use reflective, transmissive or both lighting techniques for reliable, consistent and accurate detection. In this installation, standard type reflective lighting was used for illumination. The principle of this part of the system, however, is confidential and proprietary. Nonetheless, similar to the discrete defect detection, the absence or increase in light plays an important roll in the overall detection capability. Of course, the signal processing, especially that designated for noise reduction is one of the main operational aspects of the ability to detect subtle continuous line defects.

A schematic of the system used for subtle continuous defects such as coating streak detection, using the same frame, cabinet, and computer, but different sensors, lighting techniques and electronic processing techniques, is shown and described in *Figure 2*.

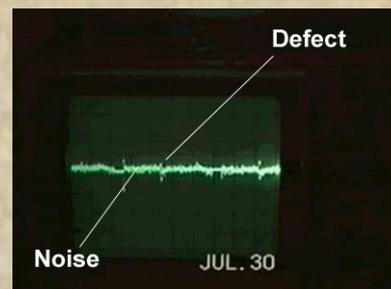
Figure 8 – Signal to noise of streak using line scanning techniques

Since material base colors and coating colors are generally similar in appearance as a coating streak defect, the streak or scratch generally does not facilitate a significant increase or decrease in energy (luminance) received by a sensor. Therefore the electronic noise level appears the same or similar to the actual material in which the defect is present. In most cases, light present at the streak edges where coating has furrowed is more widely tried by “line scanning” system integrators and suppliers in an attempt to detect the defect. Notwithstanding a slight signal at the edges of streaks, the process of furrowing in many cases does not provide for adequate signal strength where one might see a thicker accumulation of coating – *Figure 6 & 7 & 8*.

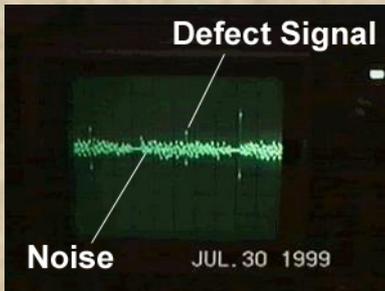
Depending on the type of material (OMC, Supercalender, Paper, Film, Metal Board, and their associated basis weights), the variations in surface transmission or reflectance can produce a great amount of electronics noise in the initial raw data (signal) out of the sensor – *Figure 9*.

Figure 9 – Initial Raw Data

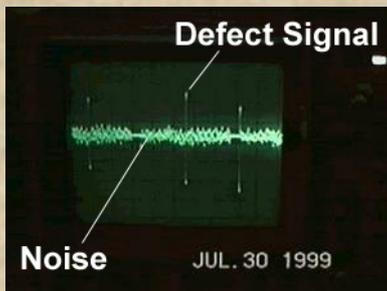
Thus, inherent high background noise makes detection of very subtle streaks or narrow scratches, much more difficult. To compensate for this problem, RKB designed proprietary noise reduction circuits that work with any color, weight or material equally and reliably. The result is a very clean, consistent signal that can be detected on a ratio as small as 1.5:1 or 200% higher than standard line scanning techniques (*refer to Figure 10*),

Figure 10 – Electronics Signal after RKB noise reduction

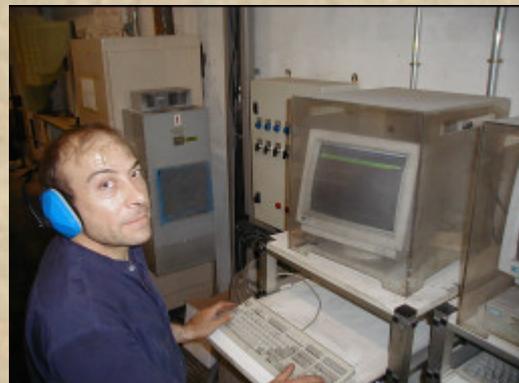
Once the defect has been processed and digitized, the output is then sent to audio/visual alarms and the main systems quality assurance management system called QAMS®. QAMS will report the type of defect, length, start and stop times and footage, exact location cross direction and machine direction, as well as many other features required for accurate data logging and historical purposes – *Figure 11*.

Figure 11 – Reno personnel utilizing QAMS.

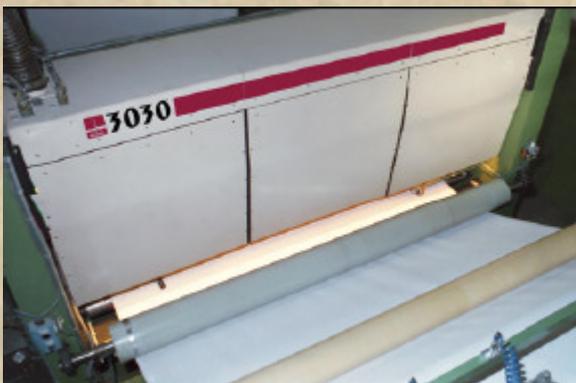
RKB System Installed at Reno de Medici s.l.

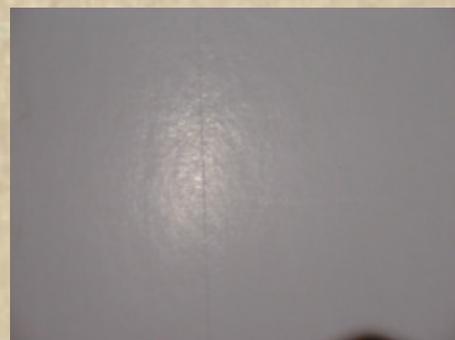
Coating Scratch

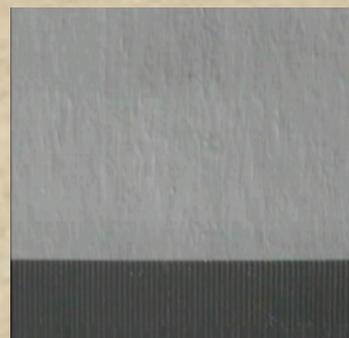
Coating Streak
