COMPARATIVE EVALUATION STUDY OF ON-LINE CAMERA-BASED WEB INSPECTION SYSTEMS

COMMISSIONED BY THE
AMERICAN FOREST AND PAPER ASSOCIATION
MEASUREMENT TECHNOLOGY COMMITTEE
(AF&PA/MTC)

Evaluation of the R.K.B.® OPTO-ELECTRONICS, INC.

MODEL 3030® OPTOMIZER® Camera-based Video Web Inspection System for Holes, Flaws, Coating Streaks and/or Scratches

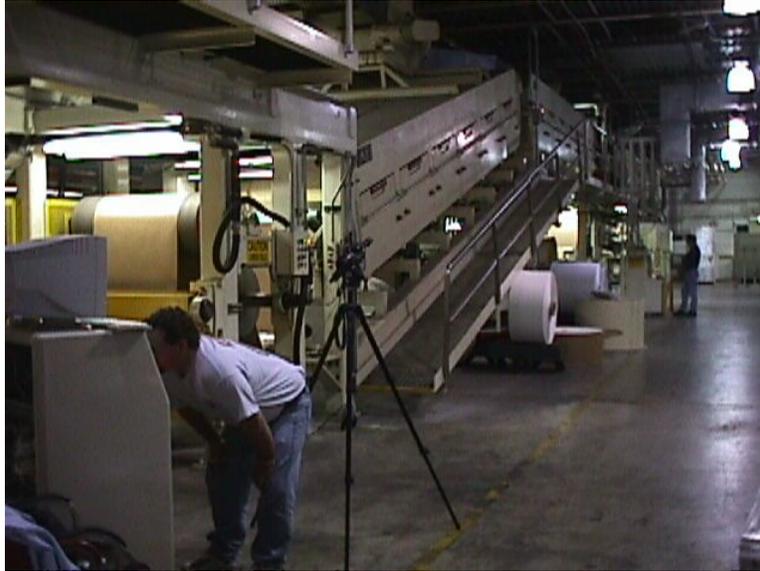
The production machine in which the trial evaluations were conducted was the pilot coater machine located at Appleton Papers, Inc., Appleton, Wisconsin, USA. The machine is located in a separate building away from many environmental conditions that normally are present in the mill. The climate was very clean and dry (Figure 10). All products provided were pre-manufactured thus eliminating the need to actually use coaters and dryers. Vibration from the machine was minimal and ambient light had no affect.

Figure 10 – Pilot Coater Mill Environment

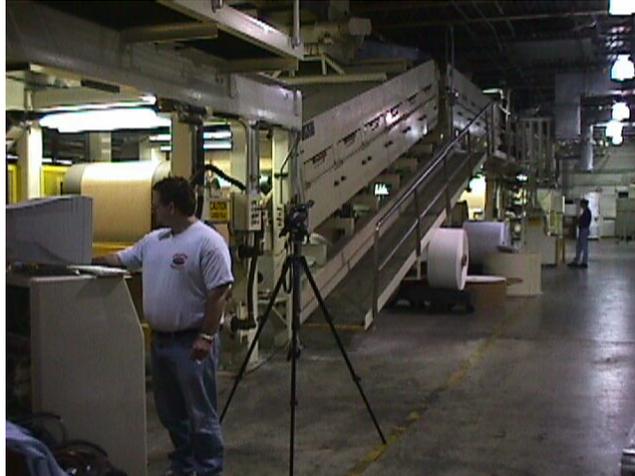
Figure 16 shows the location along the line of the pilot coater where the measurements were taken. At this location the web is horizontal at 1 meter above the ground and perpendicular to the optical axis of the cameras. The location is close to the end of the line.

Figure 14 - Partial View of Pilot Coater Line. RKB Model 3030 was installed close to the take up reel. Paper is moving towards the left of this picture.

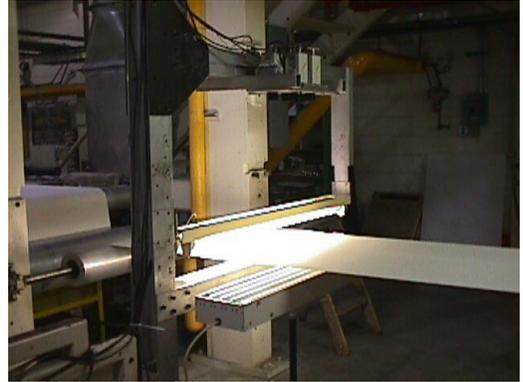
The demonstration equipment was set up to view holes, spots and coating scratches. The system inspection “C” frame was placed on the pilot coater just prior to the take up reel and aligned between the calender and mount hope roll. Inspection sensors were placed above the paper web. The light source assemblies were positioned above and below the paper web approximately one to two inches from the sheet (Figure 22). The placement of the sensors allowed for an eight-inch (20.32-cm) field of view per sensor for scratch detection and 13.5 inches (34.29 cm) for hole and spot detection. RKB adjusted the sensitivity of the system so that it was set at approximately a 2:1 signal to noise ratio for scratches and a 3:1 signal to noise (Figure 23) for holes and spots. Adjusting the signal to noise ratio or detection threshold will eliminate the potential false signals that can be generated by the product noise. The IPST provided various rolls of paper from coated to newsprint for evaluation. Since all products supplied already contained defect faults, there was no need to activate the actual coating station or dryers on the pilot machine. Pilot coater speed was checked and verified to run between 2500 fpm (762 m/min) and 5000 fpm (1524 m/min) per IPST specification. Defects of various sizes were provided and pre existent. Each material roll will be tested two to three times in the same direction and placement to verify repeatability.

Figure 17 - Placement of lighting across pilot coater and paper web

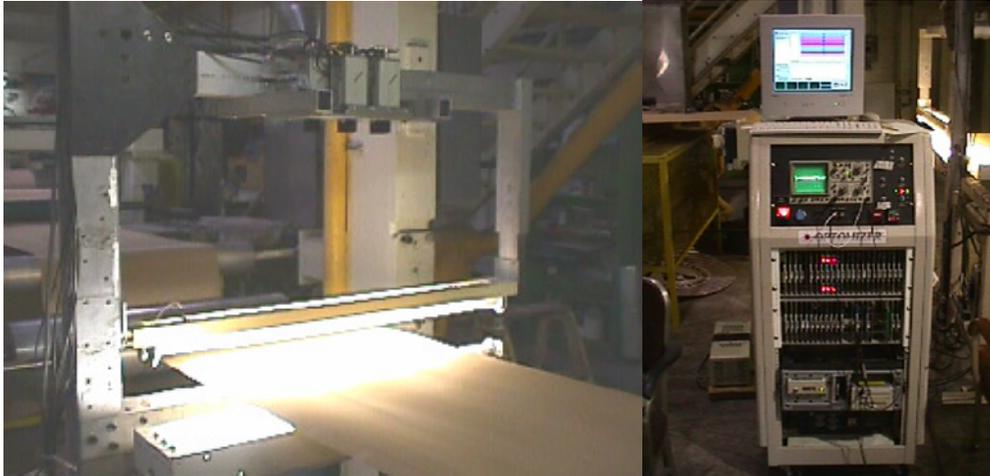
Figure 20 - View of the Inspection Assy and DCS during the trial with the 33-lb Linerboard Export

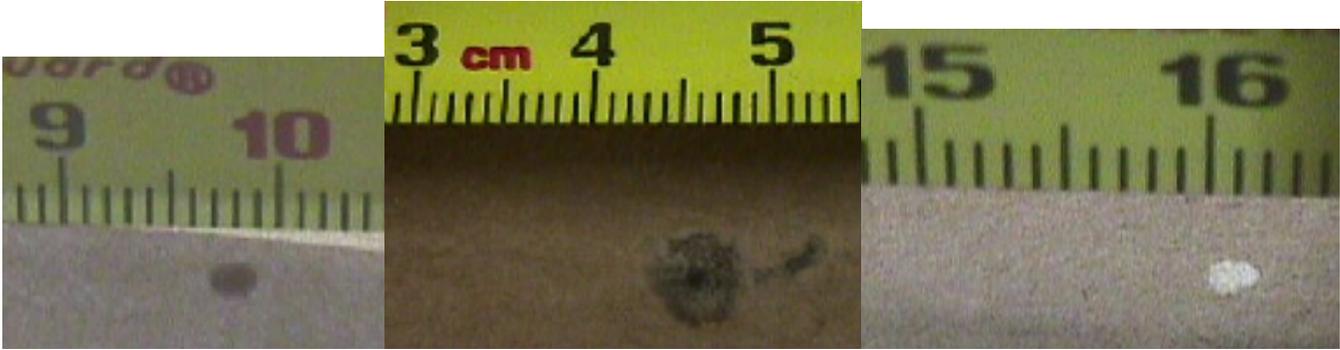
Figure 28 – Pictures of defects detected at production speed during the 33-lb Linerboard Export Test. Defects include a light spot, oil and type of scale

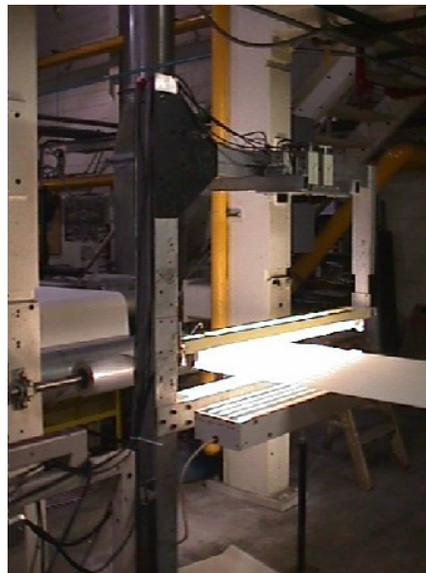
Figure 22 - View of newsprint roll A sagging prior to inspection due to excessive web flutter

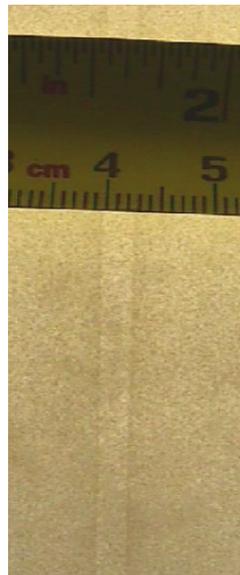
Again, as in the second run, the coating streak was detected and specified correctly (Figure 31). In this case, the product was not rewound thus the coated side faced the sensor unlike the second run. As with the second run, IPST personnel observed it, the streak jumped from camera to camera just after the splice. In this case, it jumped from camera two to camera one. Upon completion of the test, the roll was taken away and IPST started preparation for the next coated grade, Accolade Gloss Roll A.

Figure 24 - Picture of a coating streak detected by the RKB Model 3030 during the Choctaw Matter Roll A evaluation

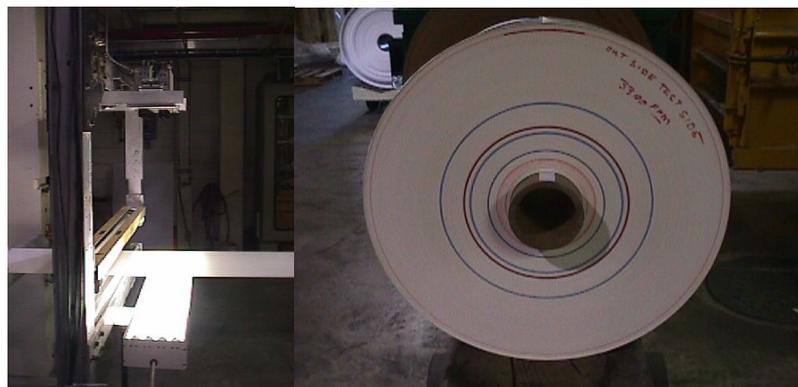
The test data and evaluation indicated that the unit was setup correctly and no apparent adjustments were required or performed. The defection threshold for activation of streak defects was set at <0.4 volts for narrow, 0.4 volts to 1.2 volts for medium and 1.2 volts for large. The unit indicated streak detection and was verified not only by the systems software, but by a small Sony TV monitor that is included with part of the unit for visualization. Additionally observed by IPST and RKB personnel were additional streaks that appeared to come and go quite frequently. These signals appeared to move right and left along the cross direction of the web. These scratches appeared on both sides of the web. The characteristics of the scratches were such that reflected light most likely would be required for more consistent pick up. The wider and more apparent streaks were observed by IPST, Appleton and RKB personnel and were visually verified via the TV monitor, data logging and by the oscilloscope. The roll of paper was marked upon detection of the large coating scratches with blue ink on the side of the web indicating location (Figure 32).

Figure 32 – View of inspection assembly during run and a picture of the Accolade Gloss Roll with defect location marks.

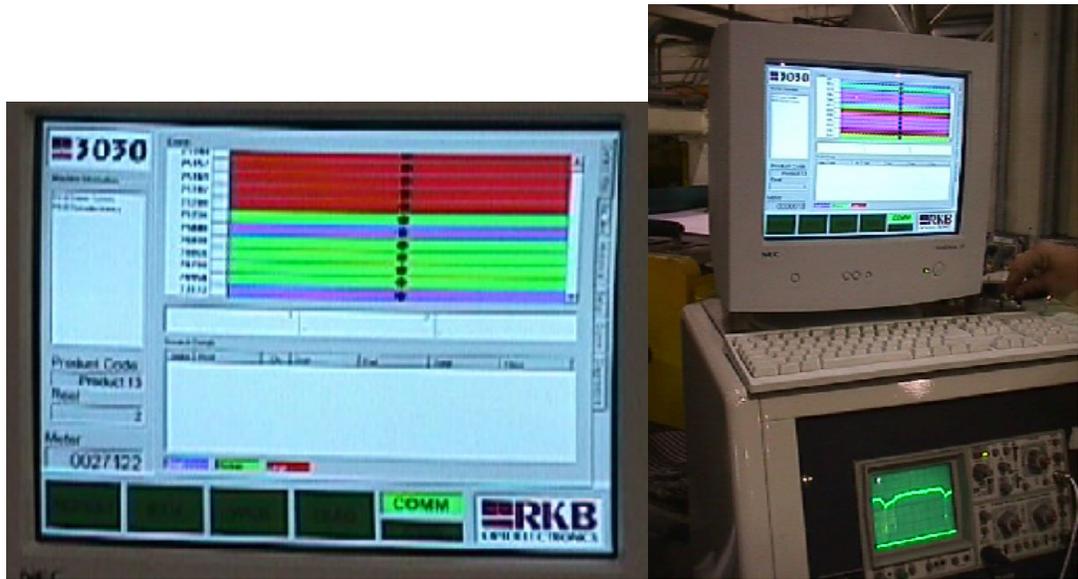
Figure 33 - View of cabinet and CRT screen during trial with calibrated defects. Each Red strip indicates a large size defect, Green medium and Blue small.

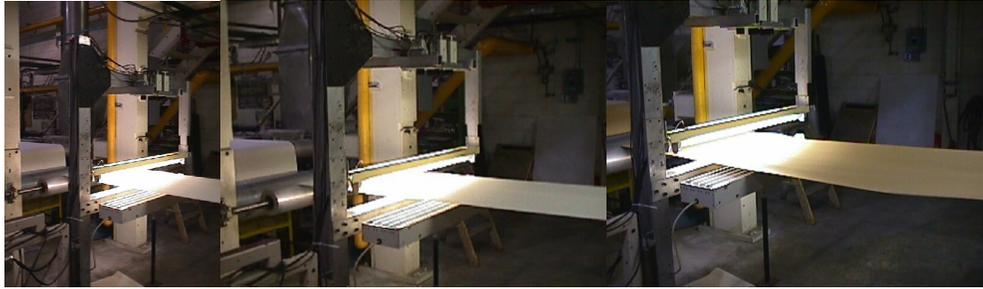
Figure 34 - Showing the web sagging problem during the Newsprint A trial run that contributed to web breaks.

After some adjustments we were finally able to reach 5000 fpm (000 m/min) and start acquiring data. Then after five seconds of data acquisition at 5000 fpm the web directional control couldn't respond fast enough. A web break occurred that caused a huge paper Jam (Figure 35). A long section of the roll was lost and the roll was split into two rolls with the smallest roll not negligible in diameter. Both rolls were removed from the machine.

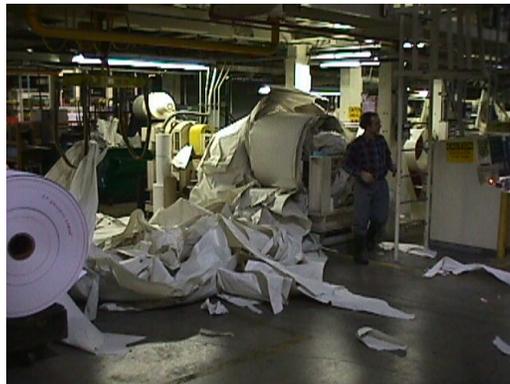
Figure 25 - Web Break of Newsprint Roll A

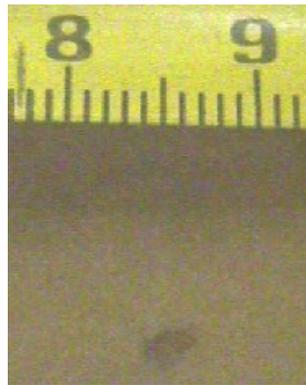
That data collected (Table 29 above) was favorable according to the settings and conditions. The web exhibited quite a lot of sagging and flutter, which affects the detection capability as the web significantly moved in and out of focus to the sensor. This problem may have been caused by mechanical problems in the pilot machine during the break problems the day before when operational speed was running up to 5000 fpm (000 m/min). The outside surface of the web was facing up towards the sensors. During this test, the footage module was not connected so it was not possible to know exactly the location of the defects in the web. However, the defect count overall was not affected nor was defect detection. Figure 36 depicts a defect that was detected during this trial run. The divisional ruler used was in metric and divided by centimeters. Each graduation represented a millimeter. The spot defect was approximately 3 to 4 millimeters diameter.

Figure 26 - Picture of spot defect detected during linerboard import test run

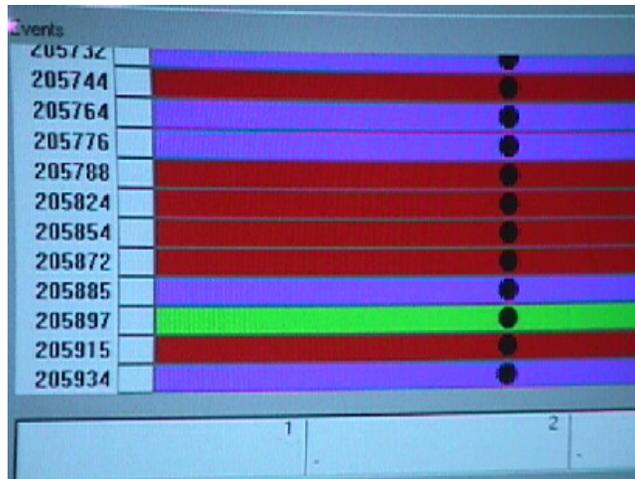
Figure 27 - Real time mapping of defects. All defects are dark spots of different sizes

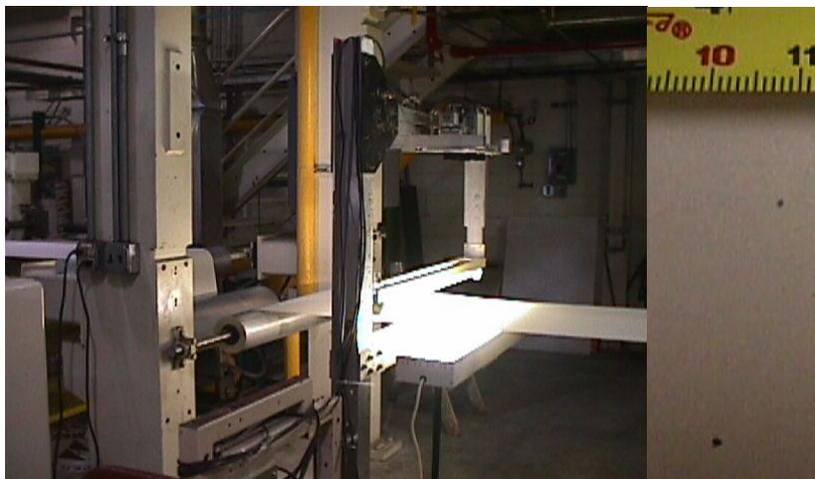
In this trial run, a lower speed was deliberately used as to avoid continual web break problems. Contrarily to Thursday, the CD position of the web was much better controlled because of some new adjustment made on the pilot coater by operational staff. Below are two photos (Figure 38) depicting the newsprint web again, sagging during the run and a picture of defects actually detected and marked for verification. The divisional ruler used was in metric and divided into centimeter with the small graduations representing millimeters. As seen in the photograph of the defects, the defects were approximately 1 millimeter diameter or larger. This is significant as it does correlate to the sizing set by the RKB operational software program and showed correct sizing and classification during detection.

Figure 38 - View of frame during the trial with Newsprint roll A and defects on newsprint.

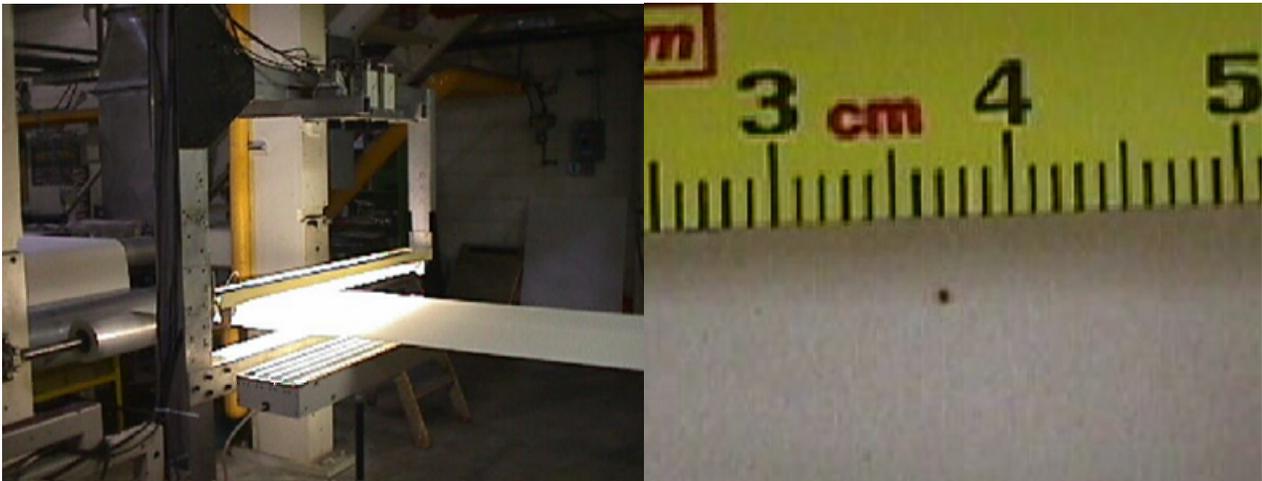
Acquisition of data occurred between the 2nd red mark and the black mark (1st red mark was when the coater reached maximum speed of 3500 fpm) at a constant speed of 5000 fpm. No web breaks occurred and the test was completed up to the end at 5000 fpm without any noticeable pilot machine problems. Data files are currently being processed and analyzed. Figure 39 shows the equipment and a spot defect detected during this run.

Figure 39 - Camera frame during testing of Newsprint Roll B and a spot defect detected during the run.
