Maximize Profitability

Production efficiency standards that facilitate continuous quality control initiatives and machine runnability are essential key components to ensure a competitive edge in this very demanding segment of the market. The Model 3600 OPTOMIZER® FCS Sheeter Inspection™ Technology will provide comprehensive quality management to ensure defective material is detected, classified and diverted from one to multiple successive sheets prior to stacking.

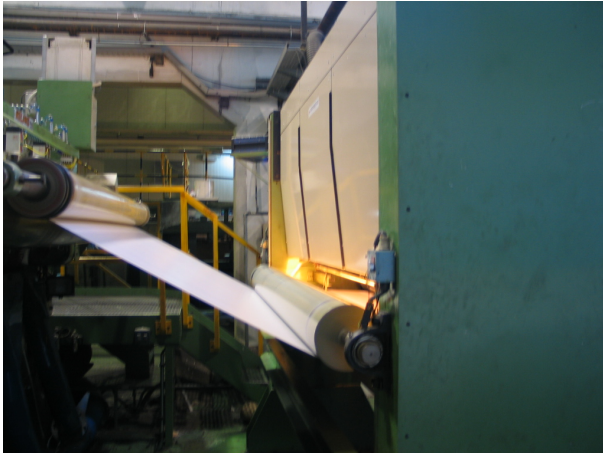
The inspection technology is mounted prior to the cutter in-feed. Upon detection of critical defects, a reject gate will be activated momentarily altering the flow of the sheeted material allowing the "BAD" sheets to divert into a reject bin. This ensures the skids of sheeted stock remain free of critical defective product at the source and not at your customers' process. These quality initiatives will prevent and reduce smash blankets, press downtime, damage to sensitive components or coating equipment and delivery delays costing you customers and market position.

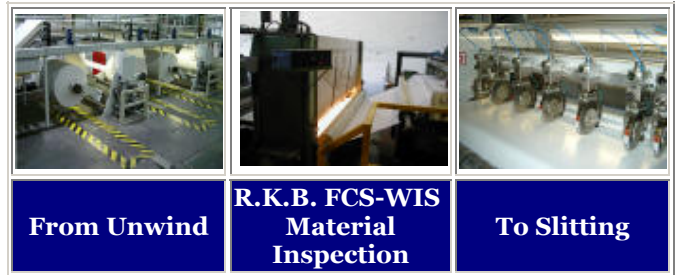
| Coating Scratches | Coating Streaks |

| <p>COATING SCRATCH</p> <p>For this sample our patented coating scratch sensor was utilized with our proprietary data processing circuitry. A transmissive light source was used to maximize the defect to the material background. The sensor used a 25mm lens and was placed with a 2" (50.8mm) field of view in the cross machine direction.</p> <p>As seen in the accompanying oscilloscope photo, the results achieved were excellent. The signal to noise ratio, as shown, was 7:1. This indicates the scratch defect shown here is highly detectable.</p> | <p>COATING STREAKS</p> <p>This sample consists of several streaks on a coated paper. Once again, our patented coating streak sensor with proprietary circuitry was used. A transmissive lighting technique was utilized to enhance the defects of interest. A 25mm lens was used and the sensor was placed with a 2" (50.8mm) field of view in the cross direction.</p> <p>As seen in the accompanying oscilloscope photo, the results achieved were very good. The signal to noise ratio was 4:1. This shows that the coating streaks are highly detectable.</p> |

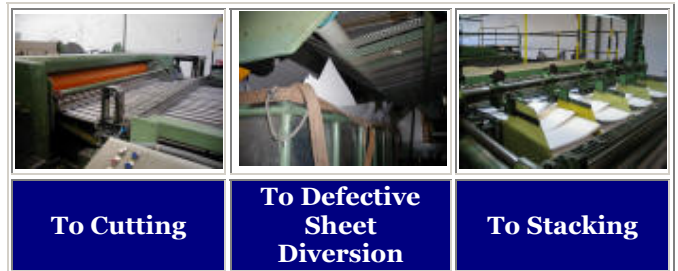
| Dirt Type Defects | Hole Type Defects |

| <p>DIRT (Black Spots)</p> <p>This sample consists of a light black spot (dirt) on a coated paper supplied by International Paper. Our Opto-TEK sensing technology was utilized with a reflective lighting technique. The sensor was positioned with a specific field of view and at a slight angle to the material to facilitate a maximum contrast of the defect to the material general background (signal to noise).</p> <p>As seen in the accompanying oscilloscope photo, the results achieved were excellent. The top 10-amp trace is the output of the defect in raw form. The bottom trace depicts the signal in digital format. The overall signal to noise ratio achieved was approximately 20:1 which indicates that the defect is highly detectable. (Please note the two visible signals on the top trace used when the customer circled the defect for purposes of indicating location).</p> | <p>HOLES</p> <p>This sample shows a large hole. The RKB OPTO-TEK sensing technology was used with a transmissive lighting technique. The sensor implemented a 25mm lens and was placed with a 10 inch (254mm) field of view in the cross machine direction. The sample was placed perpendicular to the sensor to maximize the contrast of the defect to the material background (signal to noise).</p> <p>As seen in the accompanying oscilloscope photo, the results achieved were excellent. The signal to noise ratio, as shown, was 20:1. This indicates that the hole defect shown here is highly detectable.</p> |
